Main Relay

How to Fix Your Honda Main Relay

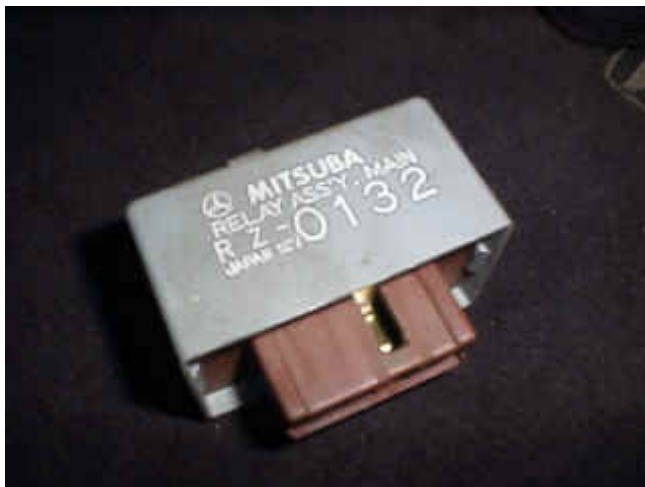
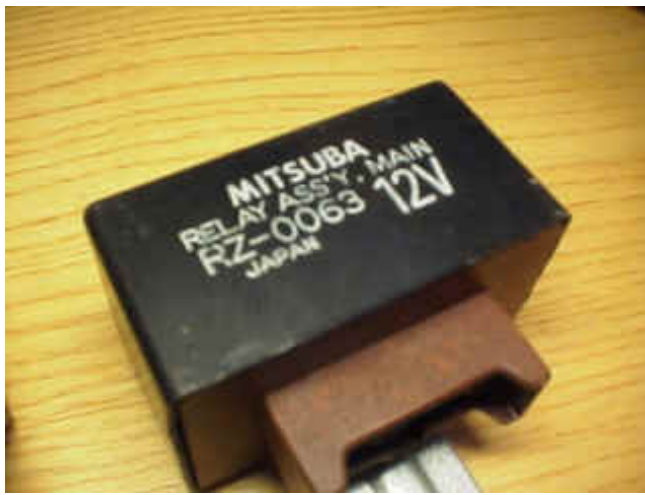
The above pictures show two main relays, the grey one from a UK Civic VTi (left), and the black one from a JDM CRX-Si (right).

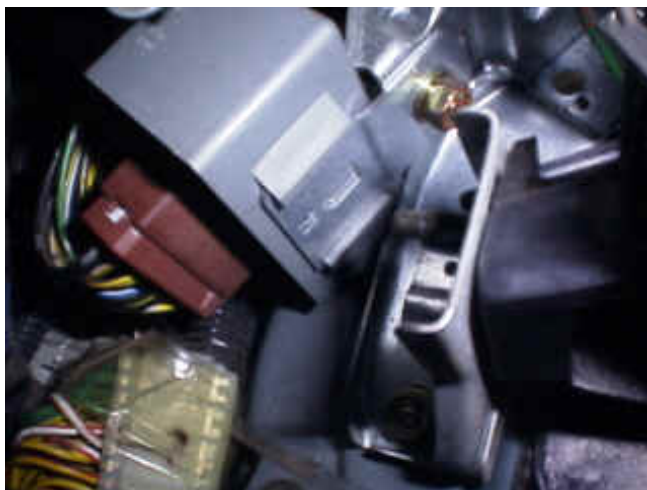
The main relay is usually located in the fuse box area, and you basically can't miss it. The picture above shows the location in a Civic VTi saloon. In the MK2 CRX and MK4 Civic, it is in a more restricted location, click [here](#) to get a more detailed view. Remove the 10mm mounting bolt, and then depress the latch on the connector, and pull to remove.

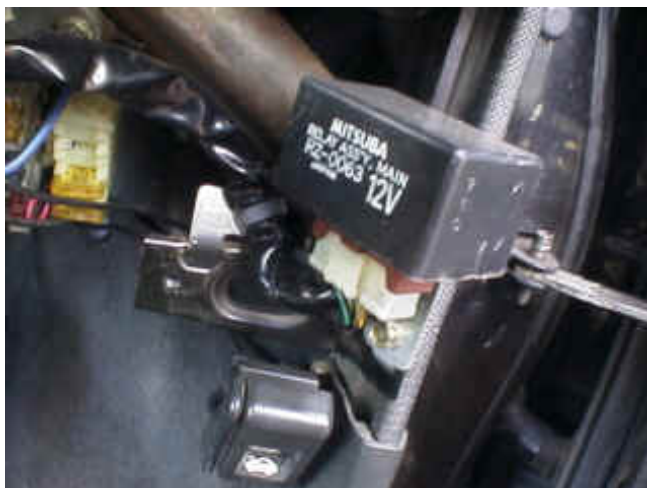
Here is a shot of where the main relay is mounted in the MK3 CRX and MK4 Civic. I took this picture when i changed my dash.

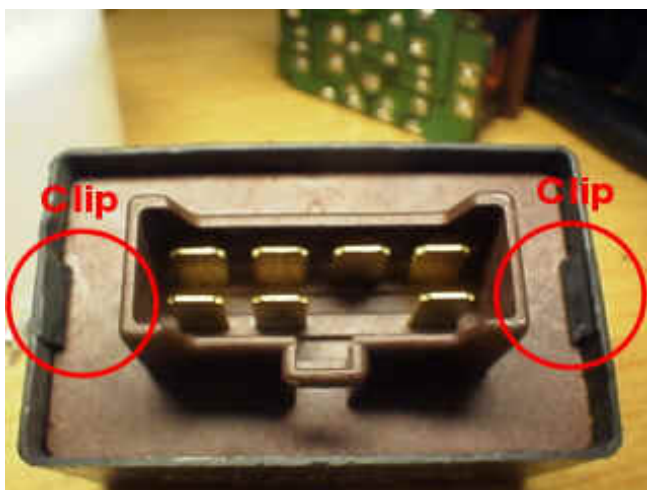
Removing The Relay Cover

To remove the cover from the relay, you need to bend back the clips on the cover that hold it in place. This can be done with gentle pressure without any tools at all, though it is sometimes easier to unclip one side at a time with a fine screwdriver.

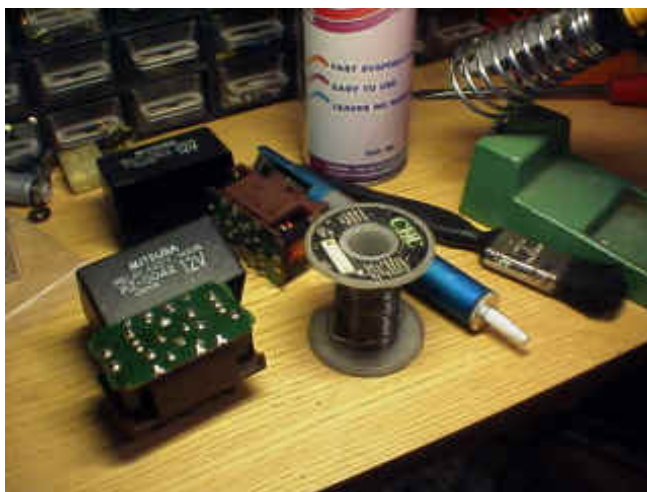
The Tools Required

Here are the tools that you'll need:

- Soldering Iron (Antex 15w), and Stand
- Desoldering Tool
- 60/40 Electronic Grade Solder
- Flux remover
